**Flood Control Project Maintenance
Levee Inspections**

Fall 2014 Levee Maintenance Deficiency Summary Report

Sacramento Maintenance Yard East Levee Yolo Bypass

Levee Inspection Report By Mile - Fall 2014

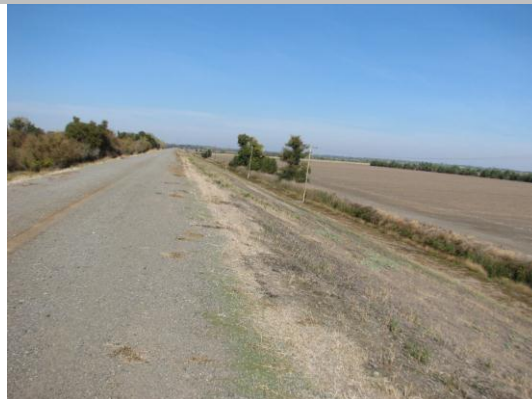
Photo 1 of 1 : FA_2014_ST0004_41_1_20141106_00002.jpg

LM Start	0.01	Rating **	A	Issue No.	1		
LM End	2.00	Issue Type +	Ma	Location *	LS		
Category	Earthen Levee			GPS Latitude/Longitude			
				Start		End	
Item	Vegetation				°		°
					°		°
DWR ID	DWR_ST0004_01_f_2014_1						
Action/Comments							
Control annual grass and weeds on the levee slopes and easements.

Levee mile 1.98, vegetation on levee slopes and crown. Fall 2014.
